CAVE BUTTES DAM FOUNDATION REPORT GILA RIVER BASIN:
PHOENIX ARIZONA AND VICINITY (INCLUDING NEW RIVER)(U)
ARMY ENGINEER DISTRICT LOS ANGELES CA AUG 83

20. ABSTRACT (Continue on reverse side if necessary and identify by block number) A summation of the foundation exploration and subsequent foundation treatment and grouting program during construction of Cave Buttes Dam near Phoenix, Arizona. Includes 94 photos and 58 plates.

CAVE BUTTES DAM
FOUNDATION REPORT

U.S. ARMY, CORPS OF ENGINEERS
LOS ANGELES DISTRICT
AUGUST 1983

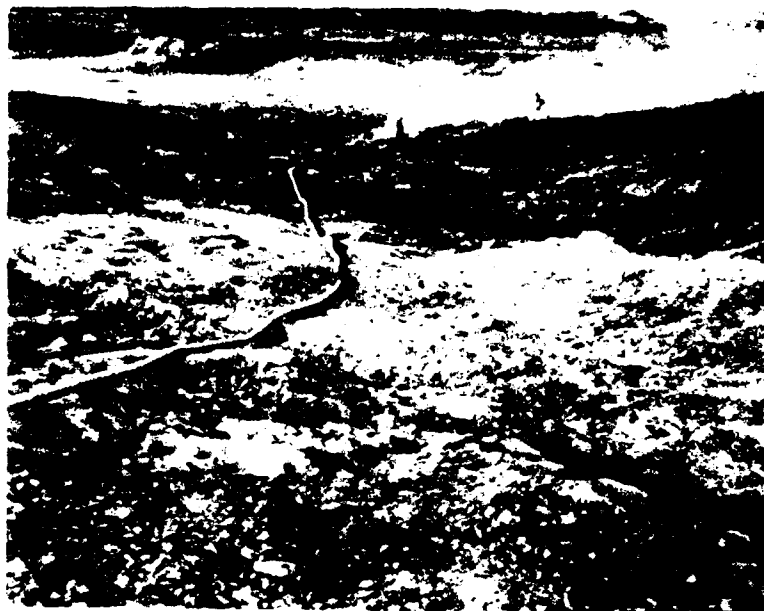
Photo 19 Left abutment. Approximate centerline of
zone I foundation from near top of dam.
20 Dec 77

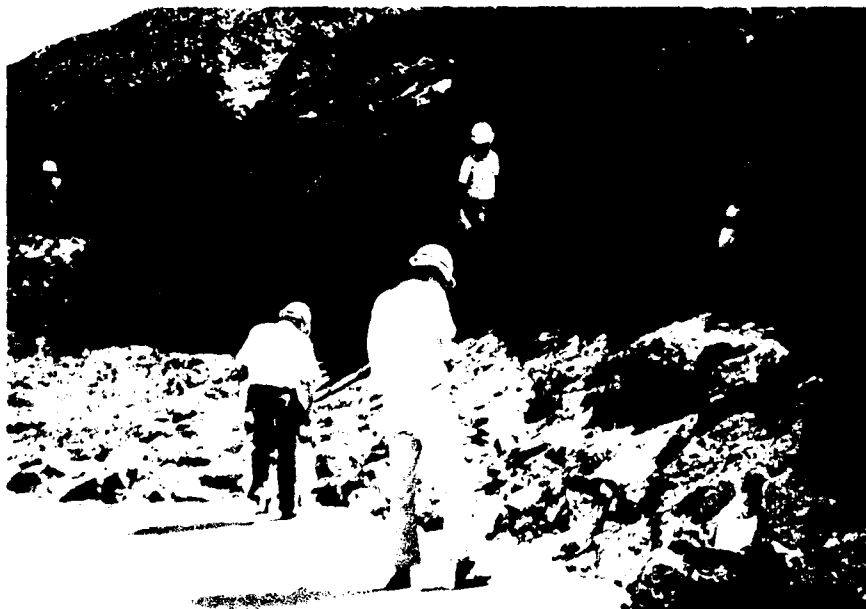
Photo 39 Outlet Works. Portion of concrete backfill near Sta. 50+00 to restore proposed foundation grade.
4 May 78

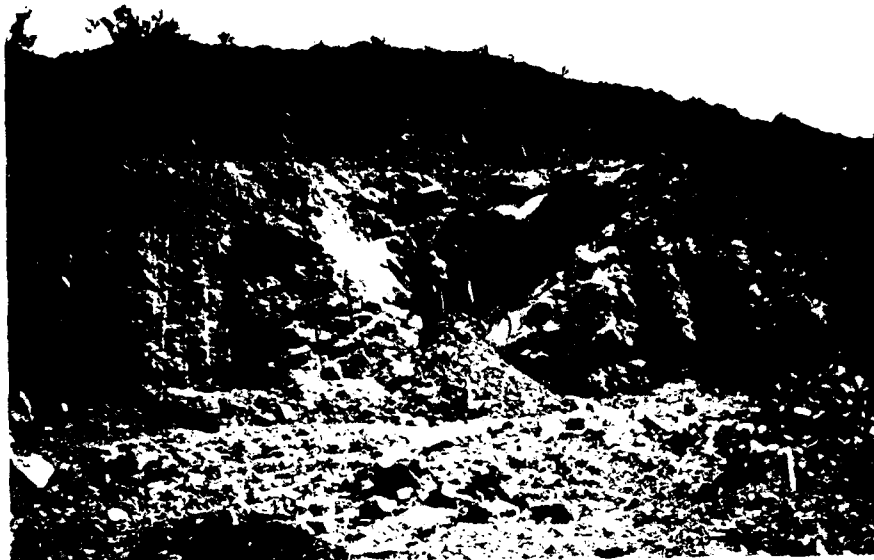
Photo 53 Spillway crest. Left (east) wall after cleaning to remove loose rock; overbreak is at notch for vertical extension of sill.

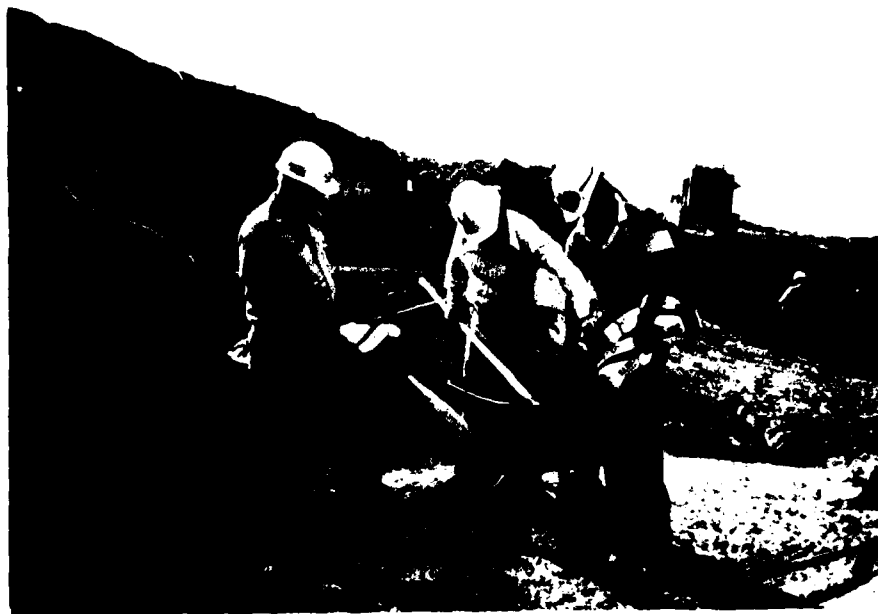
Photo 79 Left abutment between elevation 1,550 to 1,555. Foreman and crew mixing mortar and pea gravel concrete from dry pre-mixed bags for use as slurry grout to fill holes and deep fractures.

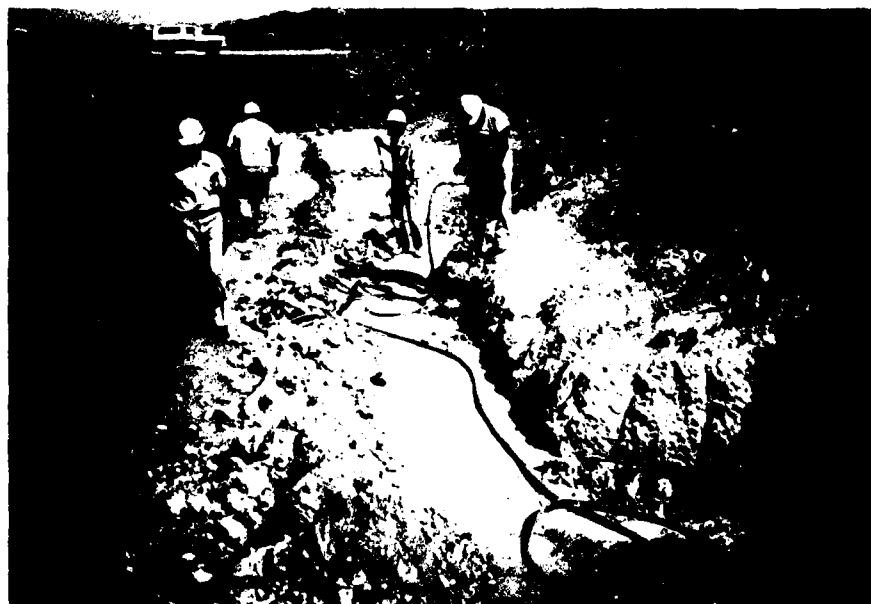
Photo 81 Left abutment. Dental concrete above outlet at elevation 1,565. View is upstream at zone I - zone II contact.
